Manhole Inspection Summary

Manhole # S67K__007MH

Insp Date: 1/14/08 1:15 PM

Location Address: **900 Dundalk Ave.**

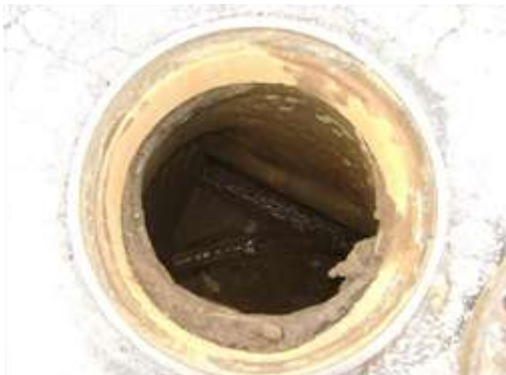
Offset: **2** (in.)

Frame offset defect

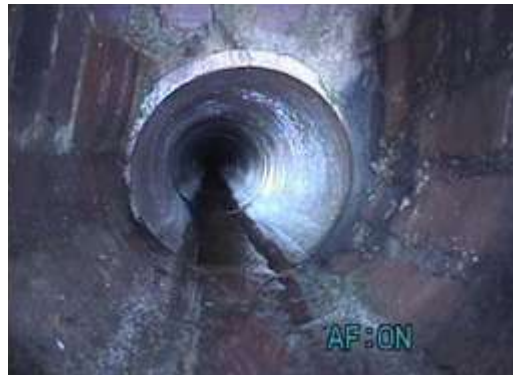
Defect 2

Comments **CRACK LONGITUDINAL 12:00 INCOMING 6 O'CLOCK**

Frame offset defect

Crack longitudinal 12:00 incoming 6 O'Clock pipe

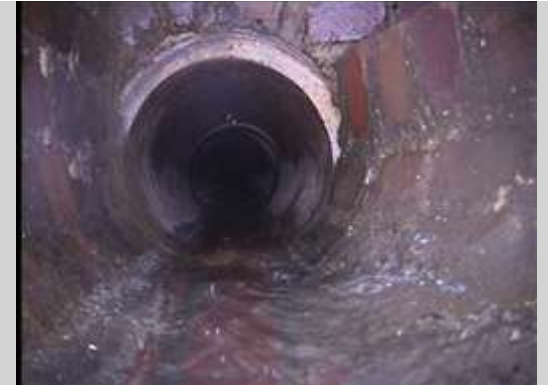
12 O'Clock Outflow

10 in. Circular Gravity Sewer
Pipe Out @ 12 O'Clock

Pipe Height: **10.8** (in.) Rod and Bar (Angled)
Pipe Material: **Clay** ☐ Pipe Lined
Invert Depth: **10.42** (ft.) Flow Characteristics: **Fast**
Deposits: ☒ None ☐ Mud ☐ Sludge ☐ Debris ☐ Grease
Silt Depth: (in.) Deposits Extent:
Infiltration: **None** Pipe Seal Cond: **Sound**

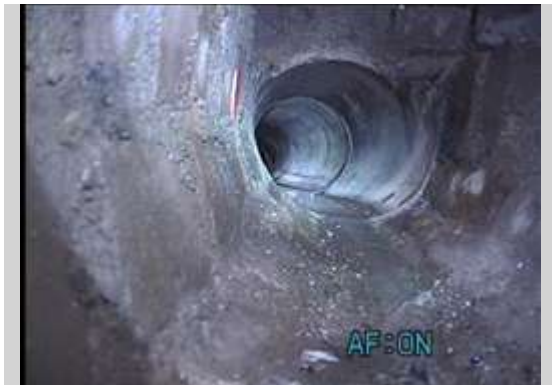
4 O'Clock Inflow

8 in. Circular Gravity Sewer
Pipe In @ 4 O'Clock

Pipe Height: **8.4** (in.) Rod and Bar (Angled)
Pipe Material: **Clay** ☐ Pipe Lined
Invert Depth: **9.83** (ft.) Flow Characteristics: **Slow**
Deposits: ☒ None ☐ Mud ☐ Sludge ☐ Debris ☐ Grease
Silt Depth: (in.) Deposits Extent:
Infiltration: **None** Pipe Seal Cond: **Sound**

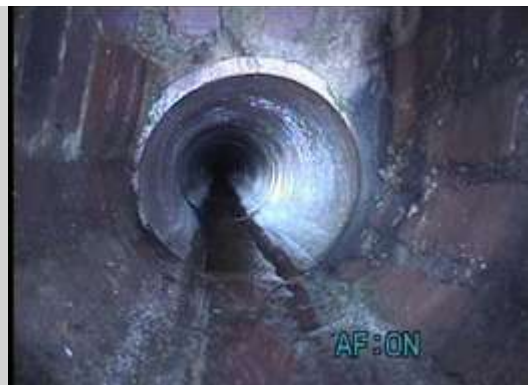
6 O'Clock Inflow

10 in. Circular Gravity Sewer
Pipe In @ 6 O'Clock

Infiltration: **None** Pipe Seal Cond: **Cracked**
